## Triple Redundancy Failure on the Space Station

November 2007

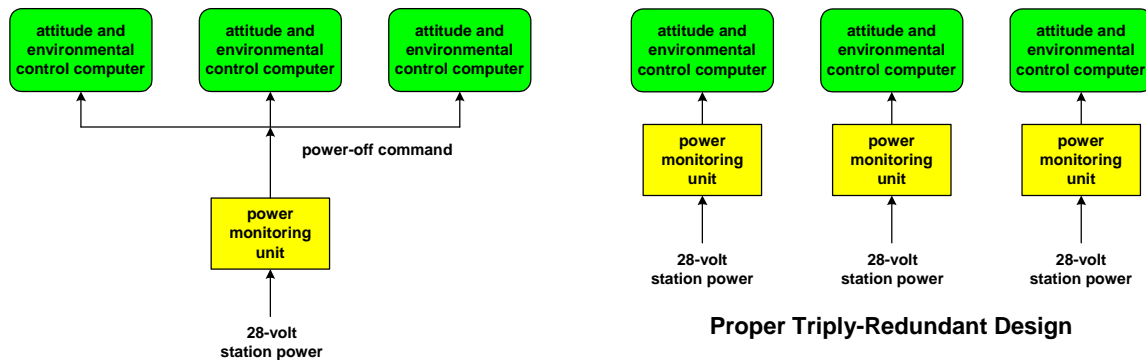
Once the problem was understood, it became clear that the system suffered from a fatal design flaw. The supposedly triply-redundant design included a single point of failure – the external power monitoring unit that, by itself, could turn off all of the computers. Should it fail (as it did due to condensation), the triply-redundant system was down.

A proper triply-redundant system design would make sure that no single failure (or even a dual failure) could take down the system. In this case, this condition could have been satisfied by providing a separate power monitoring unit for each computer.

Single Point of Failure

Proper Triply-Redundant Design
